**Flood Control Project Maintenance
Levee Inspections**

Fall 2016 Levee Maintenance Deficiency Summary Report

Reclamation District No. 2095 Paradise Cut

Levee Inspection Report By Mile - Fall 2016

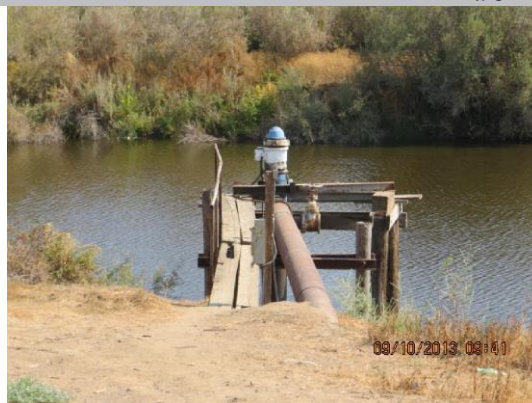
Photo 1 of 2 : UCIP_FA_2016_19787_33688.jpg

Comment Code					
Inspector Comment					
FS_ID:19787					
DS_ID:21635					
EP_NO: N/A					
Repair Type: Non-Urgent					
Crossing Status: Found					
UCIP Comments: Wooden walkway to pier possible safety hazard as wood planks are rotten. Positive closure device missing from distribution box on LS toe.					
FIELD_STRUCT_DESC: 16-inch steel irrigation pipe through the levee 8.0 feet below the crown. Pump on pile structure in the channel. 5'X5' concrete distribution box at the toe of the landward slope. Originally included in the 1964 O&M manual. Permit 18886 (2014) requested to authorize the pump station, pipe and distribution box as part of the construction of a new pipe using the same platform and distribution box.					
FS Date: 9/10/2013

Pump on pier on WS toe.

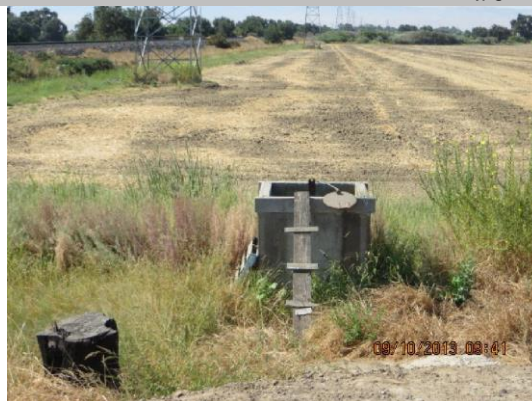
Photo 2 of 2 : UCIP_FA_2016_19787_33687.jpg

Item	DWR UCIP Field Study			37.763859 °		37.763859 °
				-121.319096 °		-121.319096 °
DWR ID						
Comment Code						
Inspector Comment						
FS_ID:19787 DS_ID:21635 EP_NO: N/A Repair Type: Non-Urgent Crossing Status: Found UCIP Comments: Wooden walkway to pier possible safety hazard as wood planks are rotten. Positive closure device missing from distribution box on LS toe. FIELD_STRUCT_DESC: 16-inch steel irrigation pipe through the levee 8.0 feet below the crown. Pump on pile structure in the channel. 5'X5' concrete distribution box at the toe of the landward slope. Originally included in the 1964 O&M manual. Permit 18886 (2014) requested to authorize the pump station, pipe and distribution box as part of the construction of a new pipe using the same platform and distribution box. FS Date: 9/10/2013

Concrete distribution box on LS toe.

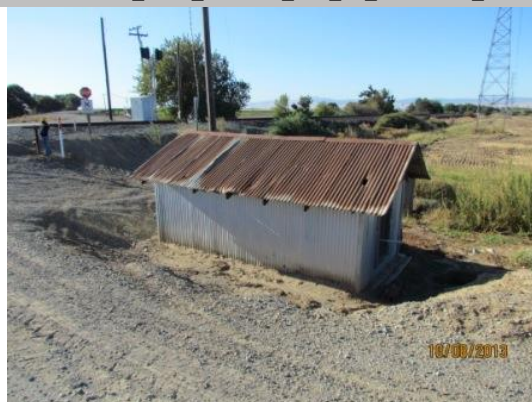
Photo 1 of 1 : FA_2016_RD2095_322_11_20160914_00006.jpg

LM Start	0.71	Rating **	M	Issue No.	11
LM End	0.71	Issue Type +	En	Location *	LS
Category	Earthen Levee			GPS Latitude/Longitude	
				Start	End
Item	Encroachments			37.763630 °	37.763630 °
				-121.319045 °	-121.319045 °
DWR ID	DWR_RD2095_01_s_2012_11				
Comment Code					
BU : Building					
Inspector Comment					
Pump house near RR.

View of building at the landside levee toe.

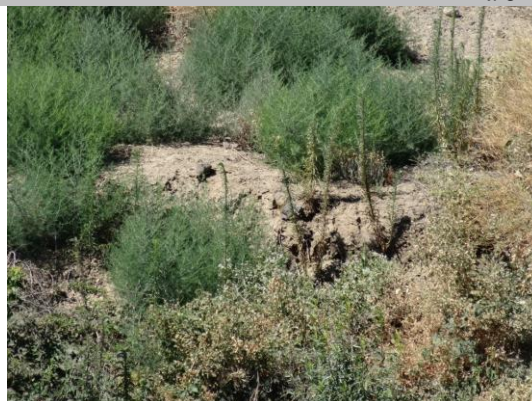
Photo 3 of 3 : SJR2016_RD2095U01RM6.74_3.jpg

Comment Code						
Inspector Comment						
07/20/2016: No significant change observed.						
08/04/2015: No significant change observed.						
08/26/2014: No significant change observed.						
08/28/2013: No significant change observed.						
07/18/2012: No significant change observed.						
09/02/2011: No significant change observed.						
09/22/2010: No significant change observed. There is now considerable vegetation at the water line and along the lower berm slope. However, the erosion on the lower berm slope is still present and has not been corrected.						
08/06/2010: Recommended for local maintenance issue, per CLRO.						
07/29/2009: No major change since last visit; noticeable vegetation growth; erosion is on berm, but if left untreated, it will eventually erode into levee prism; site is recommended for annual assessment and monitoring of the site, per CLRO CES 2008 Report; Site # is the same as RM6.80,LM0.73; previously rated "U".

07/22/2008: Downstream of WPRR near siphon pipe & pump; sandy levee; visited by Jeff Van Gilder and LRO in 2008 for repair assessment; scouring downstream of RR crossing, possibly caused by eddy effects.						
03/13/2007: Site visited on 03/13/2007. [2016 Site ID:RD2095U01RM6.74]

Close view of the erosion downstream of the RR ridge.

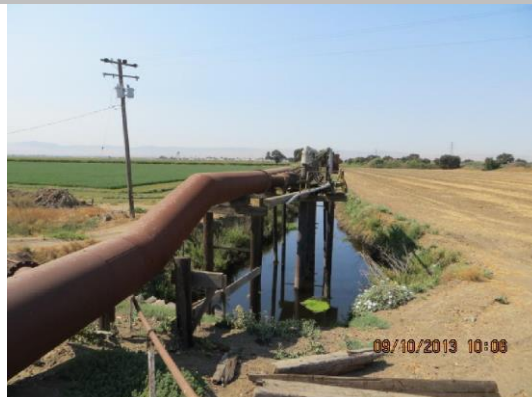
Photo 1 of 2 : UCIP_FA_2016_19812_33711.jpg

LM Start	0.87	Rating **	M	Issue No.	136
LM End	0.87	Issue Type +	En	Location *	WS
Category	Supplemental			GPS Latitude/Longitude	
				Start	End
Item	DWR UCIP Field Study			37.761582 °	37.761582 °
				-121.317881 °	-121.317881 °
DWR ID					
Comment Code					
Inspector Comment					
FS_ID:19812 DS_ID:21637 EP_NO: 13926 Repair Type: Non-Urgent Crossing Status: Found UCIP Comments: No electrical connection can be identified. Possibly awaiting a flood event for re-activation. FIELD_STRUCT_DESC: 40-inch steel stormdrain discharge pipe through the levee 1-foot below the crown. 6 pumps mounted on wooden pier at LS toe, all discharge into 40-inch pipe. Permit was for a 24-inch steel discharge pipe through levee 2.0 feet below crown with a flapgate on waterward side. But, Permit notes show it was modified in 2001 to its current status (Permit No. 13926). FS Date: 9/10/2013

Pumps on pier at LS toe. Note electrical conduit without connection on right side of pier.

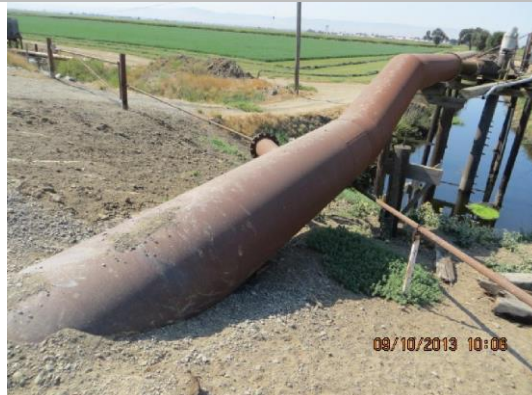
Photo 2 of 2 : UCIP_FA_2016_19812_33710.jpg

Pipe on LS slope.

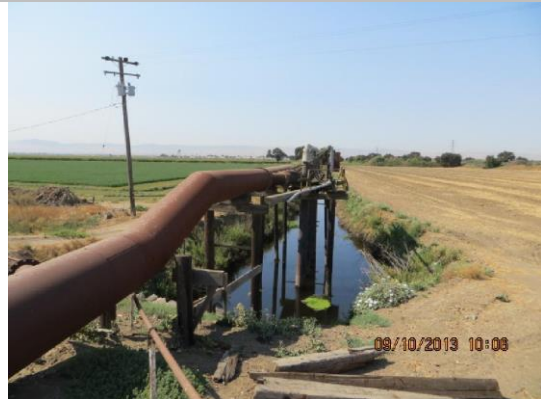
Photo 1 of 2 : UCIP_FA_2016_34387_62273.jpg

LM Start	0.87	Rating **	M	Issue No.	139
LM End	0.87	Issue Type +	En	Location *	WS
Category	Supplemental			GPS Latitude/Longitude	
				Start	End
Item	DWR UCIP Field Study			37.761554 °	37.761554 °
				-121.317847 °	-121.317847 °
DWR ID					
Comment Code					
Inspector Comment					
FS_ID:34387 DS_ID:21629 EP_NO: 6259 Repair Type: Non-Urgent Crossing Status: Found UCIP Comments: What appears to be the concrete headwall on the LS toe is tilting and failing. There is a possibility that the concrete is rubble used to fill in around levee toe. Good candidate for video inspection. FIELD_STRUCT_DESC: 30-inch corrugated metal pipe through levee 21.0 feet below crown. Slide gate in riser on the waterward slope. Concrete headwalls and aprons on both ends. Flap gate on the waterward end. Two corrugated metal cutoff walls (Permit No. 6259, 1969). FS Date: 9/10/2013

Pipe inlet located below 40-inch pipe at LS toe canal.

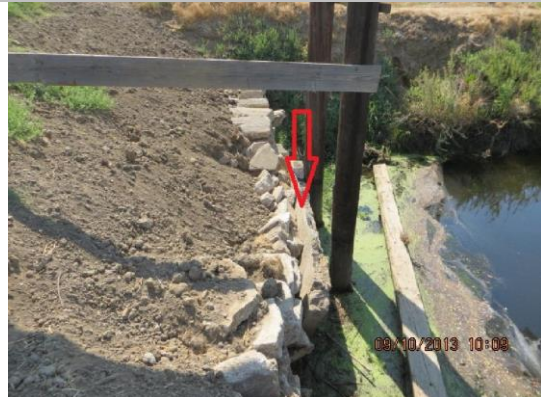
Photo 2 of 2 : UCIP_FA_2016_34387_62272.jpg

Concrete headwall on LS toe is tilting heavily towards canal.

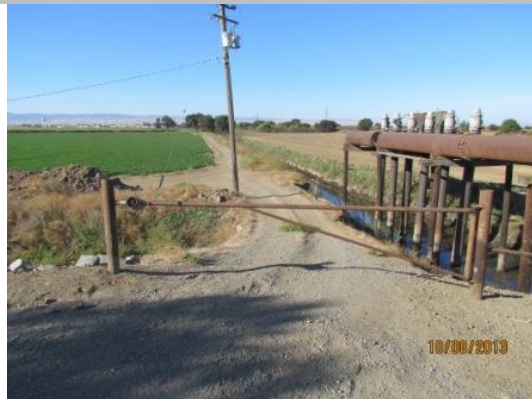
Photo 1 of 1 : FA_2016_RD2095_322_4_20160914_00004.jpg

View of the new gate at landside levee hinge.

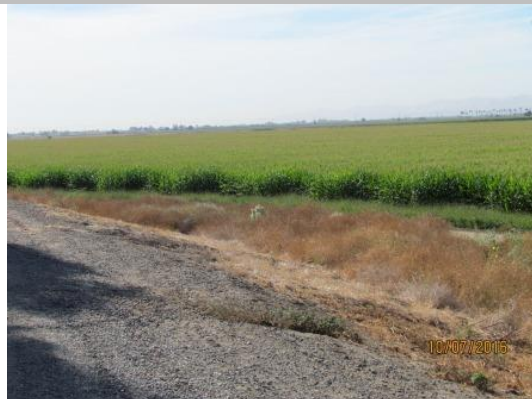
Photo 1 of 2 : FA_2016_RD2095_322_9_20161011_00026.jpg

LM Start	0.90	Rating **	M	Issue No.	9
LM End	1.44	Issue Type +	Ma	Location *	LS
Category	Earthen Levee			GPS Latitude/Longitude	
				Start	End
Item	Vegetation			37.761128 °	37.759201 °
				-121.317645 °	-121.308517 °
DWR ID	DWR_RD2095_01_f_2016_9				
Comment Code					
V1 : Control annual grass and weeds on the levee slopes and easements.					
Inspector Comment

View of the vegetation on the landside levee slope and toe.

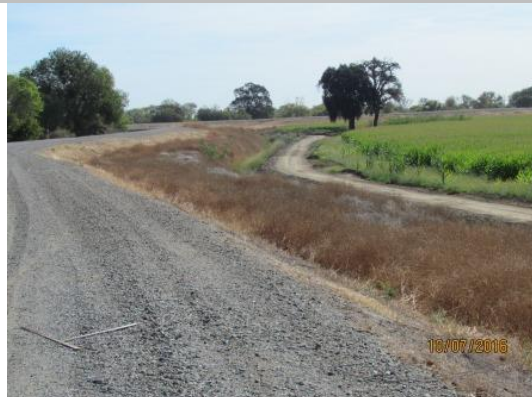
Photo 2 of 2 : FA_2016_RD2095_322_9_20161011_00027.jpg

Another view of the vegetation on the landside levee slope and toe, facing the San Joaquin River.

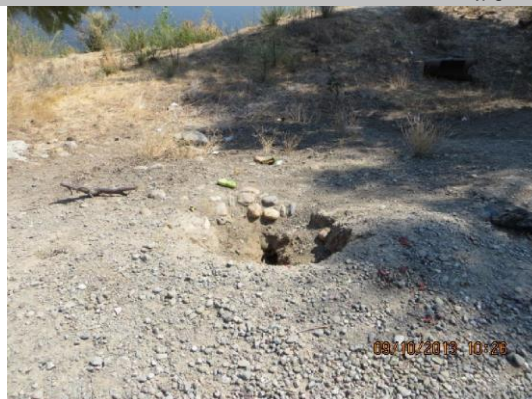
Photo 1 of 2 : UCIP_FA_2016_19815_33719.jpg

LM Start	0.91	Rating **	M	Issue No.	138
LM End	0.91	Issue Type +	En	Location *	LS
Category	Supplemental			GPS Latitude/Longitude	
				Start	End
Item	DWR UCIP Field Study			37.761079 °	37.761079 °
				-121.317567 °	-121.317567 °
DWR ID					
Comment Code					
Inspector Comment					
FS_ID:19815					
DS_ID:21630					
EP_NO: N/A					
Repair Type: Non-Urgent					
Crossing Status: Indicator Found					
UCIP Comments: Pipe abandoned and should be verified as having been done so properly.					
FIELD_STRUCT_DESC: *ABANDONED* 12-inch steel stormdrain pipe through the levee 1.5 feet below the crown. Pump on pile structure in drain ditch on landward side. Siphon breaker in steel standpipe on the waterward slope. Originally included in the 1964 O&M manual.					
FS Date: 9/10/2013

Hole on LS shoulder where standpipe may have been located.

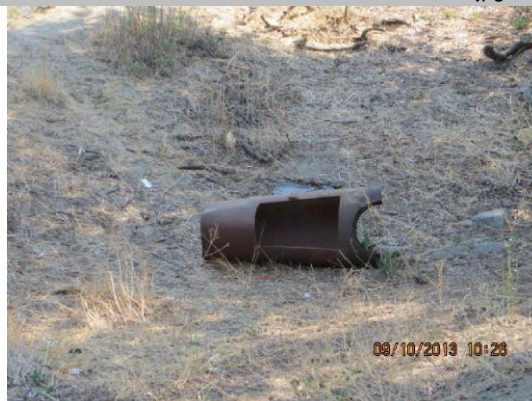
Photo 2 of 2 : UCIP_FA_2016_19815_33718.jpg

Standpipe discarded on WS berm.

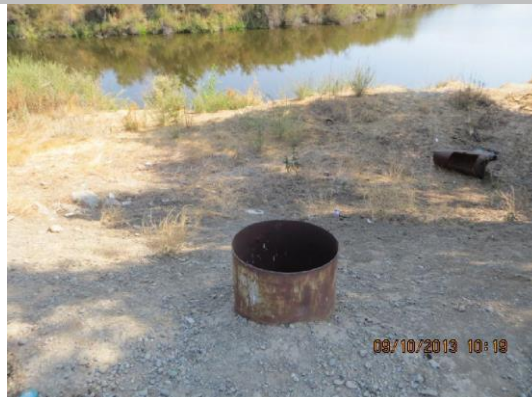
Photo 1 of 2 : UCIP_FA_2016_19813_33715.jpg

LM Start	0.91	Rating **	M	Issue No.	137
LM End	0.91	Issue Type +	En	Location *	LS
Category	Supplemental			GPS Latitude/Longitude	
				Start	End
Item	DWR UCIP Field Study			37.761046 °	37.761046 °
				-121.317540 °	-121.317540 °
DWR ID					
Comment Code					
Inspector Comment					
FS_ID:19813 DS_ID:21631 EP_NO: 6537 Repair Type: Non-Urgent Crossing Status: Found UCIP Comments: Corroded holes on pipe at outlet WS toe, good indication of internal pipe condition. Good candidate for video inspection. FIELD_STRUCT_DESC: 14-inch steel stormdrain discharge pipe through the levee 2.5 feet below the crown. Pump on pile structure in drain ditch on landward side. Siphon breaker in 24-inch CMP riser on the waterward shoulder and flap gate on the waterward end (Permit No. 6537, 1969). FS Date: 9/10/2013

Siphon Breaker/vent in 24-inch steel riser on WS shoulder.

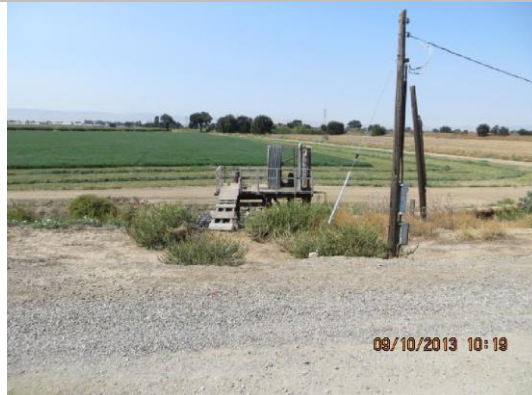
Photo 2 of 2 : UCIP_FA_2016_19813_33714.jpg

Pump on wooden pier at LS toe.

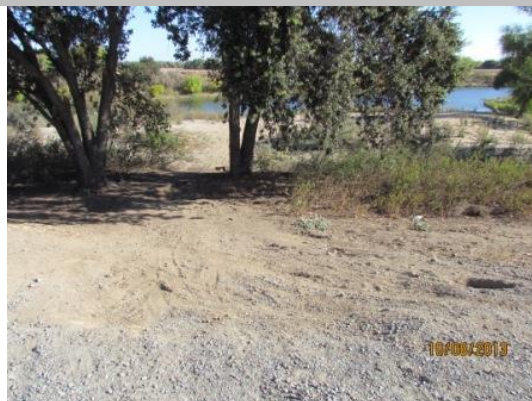
Photo 1 of 1 : FA_2016_RD2095_323_9_20160914_00007.jpg

View of the vehicle tire ruts on waterside levee slope.

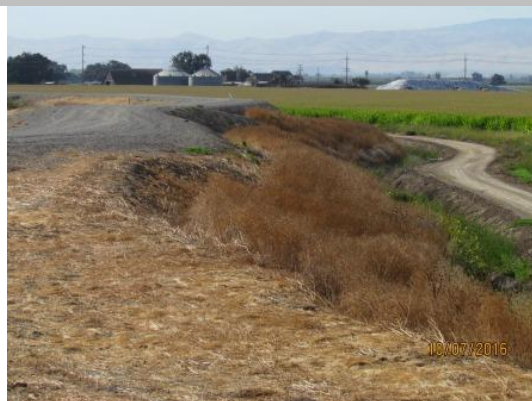
Photo 1 of 1 : FA_2016_RD2095_323_15_20161011_00027.jpg

View of the vegetation on the landside levee slope.

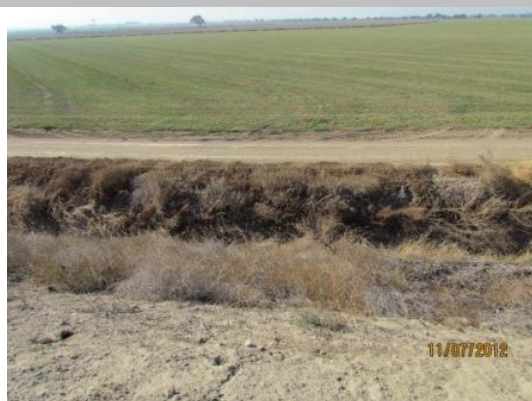
Photo 1 of 1 : FA_2016_RD2095_323_5_20160914_00006.jpg

View of a ditch along the landside toe.

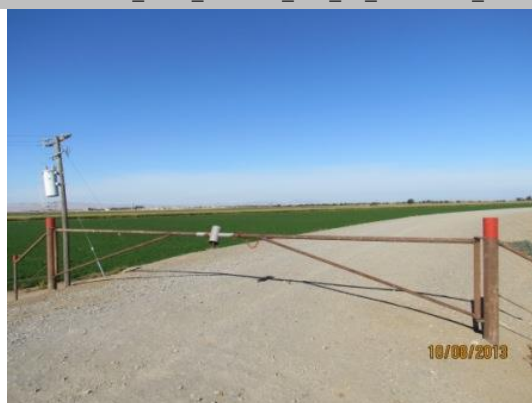
Photo 1 of 1 : FA_2016_RD2095_323_14_20160914_00009.jpg

View of new gate across levee crown.

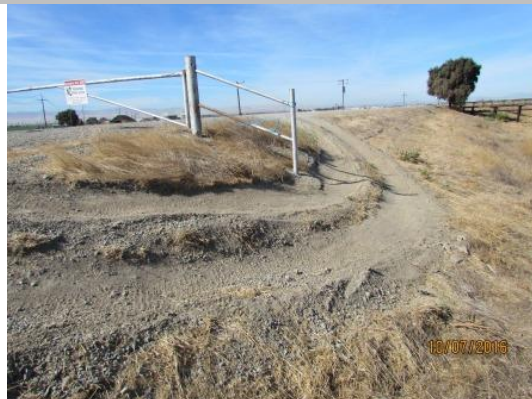
Photo 1 of 2 : FA_2016_RD2095_323_11_20161011_00021.jpg

LM Start	0.82	Rating **	M	Issue No.	11
LM End	0.82	Issue Type +	Ma	Location *	WS
Category	Earthen Levee			GPS Latitude/Longitude	
				Start	End
Item	Slope Stability			37.749644 °	37.749644 °
				-121.301960 °	-121.301960 °
DWR ID	DWR_RD2095_02_s_2016_11				
Comment Code					
S3 : Repair the levee slope damaged by vehicle traffic and prevent access where possible.					
Inspector Comment

Recent view of the vehicle tracks on the waterside levee slope, facing downstream.

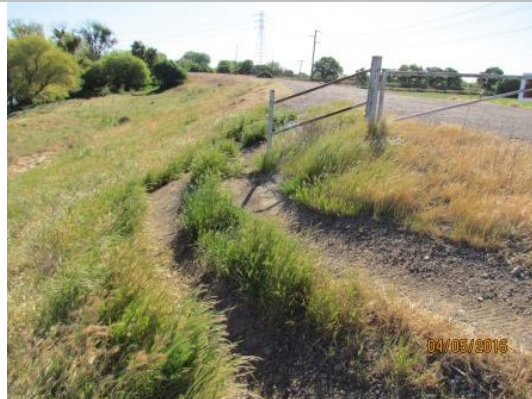
Photo 2 of 2 : FA_2016_RD2095_323_11_20160914_00008.jpg

View of the vehicle tracks on the waterside levee slope.

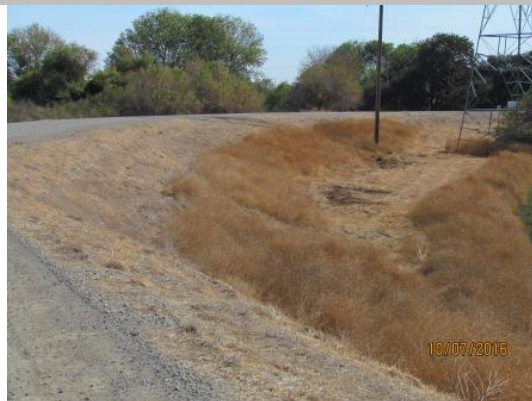
Photo 1 of 1 : FA_2016_RD2095_323_18_20161011_00022.jpg

LM Start	0.87	Rating **	M	Issue No.	18
LM End	0.97	Issue Type +	Ma	Location *	LS
Category	Earthen Levee			GPS Latitude/Longitude	
				Start	End
Item	Vegetation			37.749635 °	37.749666 °
				-121.300948 °	-121.299185 °
DWR ID	DWR_RD2095_02_f_2016_18				
Comment Code					
V1 : Control annual grass and weeds on the levee slopes and easements.					
Inspector Comment

View of the vegetation on the landside levee slope.

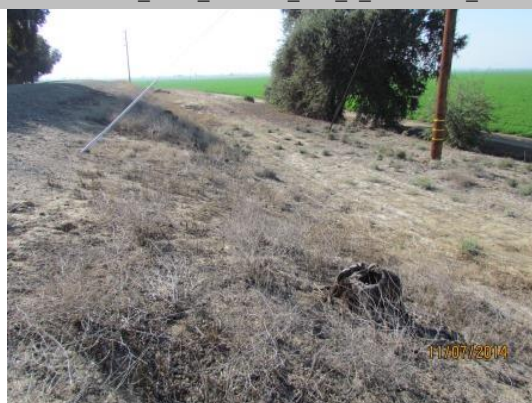
Photo 1 of 1 : FA_2016_RD2095_323_3_20160914_00005.jpg

View of the tree stumps on the landside levee slope..

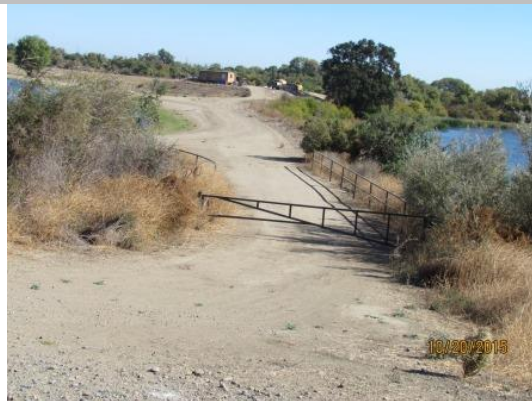
Photo 1 of 1 : FA_2016_RD2095_323_17_20160914_00010.jpg

View of the gate and fence in the floodway at the waterside levee toe.

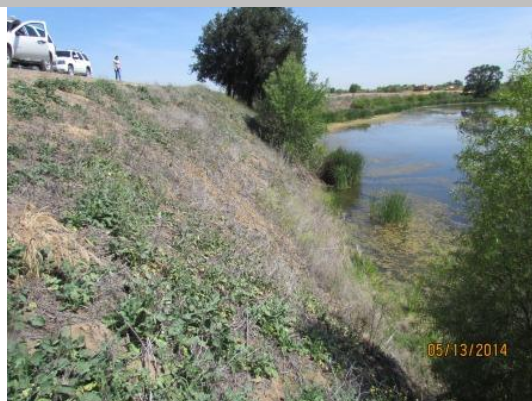
Photo 1 of 1 : FA_2016_RD2095_323_195_20160914_00011.jpg

LM Start	1.35	Rating **	A/W	Issue No.	195
LM End	1.35	Issue Type +	Ma	Location *	WS
Category	Earthen Levee			GPS Latitude/Longitude	
				Start	End
Item	Erosion / Bank Caving			37.744746 °	37.744746 °
				-121.297695 °	-121.297695 °
DWR ID	DWR_RD2095_02_s_2014_195				
Comment Code					
E1 : Note and monitor erosion site.					
Inspector Comment

View of the erosion on the waterside levee slope possibly eroding into the levee prism.

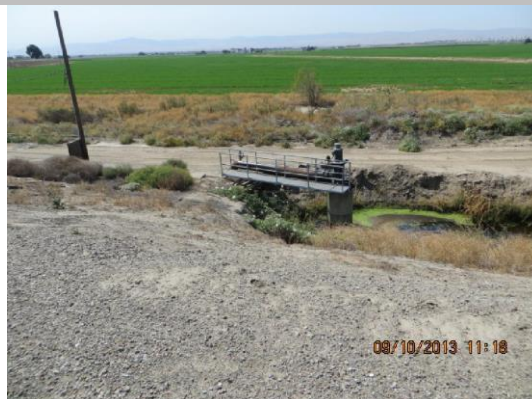
Photo 1 of 1 : UCIP_FA_2016_19863_33760.jpg

LM Start	1.48	Rating **	M	Issue No.	942
LM End	1.48	Issue Type +	En	Location *	WS
Category	Supplemental			GPS Latitude/Longitude	
				Start	End
Item	DWR UCIP Field Study			37.743142°	37.743142°
				-121.297692°	-121.297692°
DWR ID					
Comment Code					
Inspector Comment					
FS_ID:19863					
DS_ID:21642					
EP_NO: 4658					
Repair Type: Non-Urgent					
Crossing Status: Found					
UCIP Comments: Pipe appears abandoned in place and re-routed to LM 1.652. Need to verify pipe was properly abandoned. Permit FIELD_STRUCT_DESC: *ABANDONED* 14-inch pipe through levee 3.5-feet below crown. Pump on structure over drain ditch on the landward side. Flap gate on the waterward end (Permit No. 4658). Originally included in the 1968 O&M manual.					
FS Date: 9/10/2013

Pump visible on LS toe, but pipe has been re-routed to southwest.

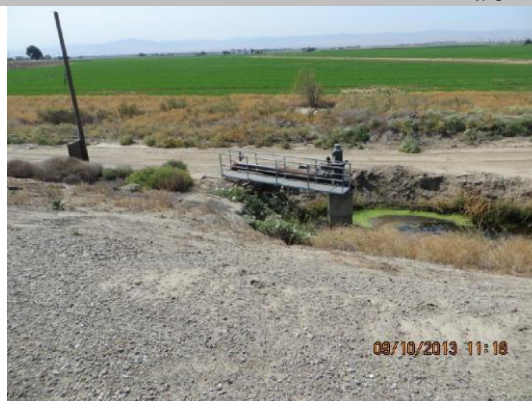
Photo 1 of 2 : UCIP_FA_2016_19866_33767.jpg

FS_ID:19866
DS_ID:21654
EP_NO: 6298A
Repair Type: Non-Urgent
Crossing Status: Found
UCIP Comments: No permit identified for this crossing.
FIELD_STRUCT_DESC: 16-inch steel stormdrain pipe through the levee 2-feet below the crown. Siphon breaker in PVC riser on WS shoulder. Pump on pier in ditch on LS toe 750-feet to Northwest from crossing.
FS Date: 9/10/2013

Pump located at levee toe 750-feet north west of pipe crossing.

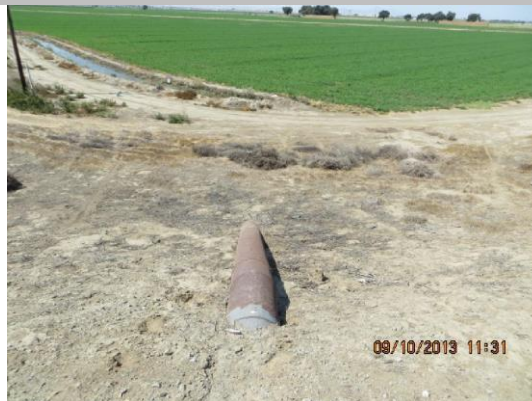
Photo 2 of 2 : UCIP_FA_2016_19866_33766.jpg

16-inch steel pipe on LS slope.

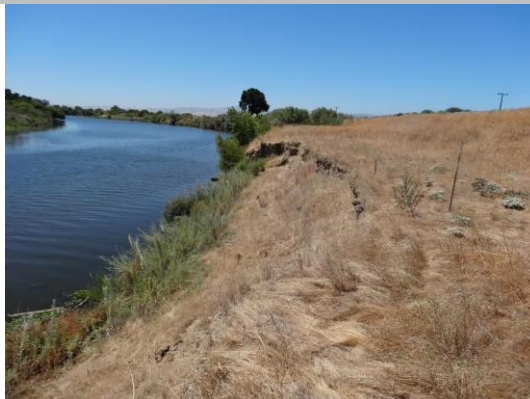
Photo 1 of 3 : SJR2016_RD2095U02RM60.62_1.jpg

07/20/2016: The erosion extended toward the levee toe. The berm width was reduced by approximately five (5) feet.
 08/04/2015: No significant change observed.
 07/02/2014: No significant change observed.
 08/28/2013: No significant change observed.
 09/13/2012: The site has been visited by land survey. The vegetation on the site shows the erosion has not developed significantly from the last survey.
 The site was not visited by boat survey due to the limitation of navigable waterway.
 08/23/2011: No significant change observed.
 9/22/2010: No significant change observed. There is moderate vegetation growth on the berm. Despite the erosion occurring on the berm, corrective action should be taken before the issue becomes severe.
 9/29/2009: Site is immediately downstream of a section of existing rip rap; there is a 20-foot berm remaining; berm will continue to erode unless erosion is mitigated; Site# is the same as RM62.6, LM1.87; recommended for annual assessment, per CES Evaluation 2008 Report 2006: Visited 10/20/06 [2016 Site ID:RD2095U02RM60.62]

Looking at the erosion from downstream of the site.

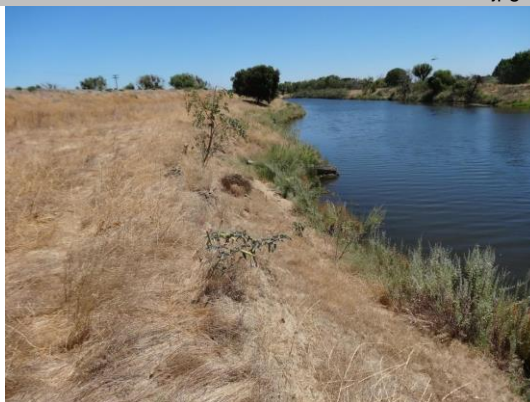
Photo 2 of 3 : SJR2016_RD2095U02RM60.62_2.jpg

Looking at the erosion from upstream of the site

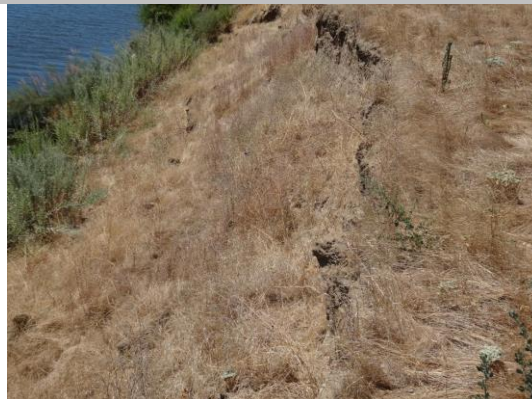
Photo 3 of 3 : SJR2016_RD2095U02RM60.62_3.jpg

Comment Code						
Inspector Comment						
07/20/2016: The erosion extended toward the levee toe. The berm width was reduced by approximately five (5) feet.						
08/04/2015: No significant change observed.						
07/02/2014: No significant change observed.						
08/28/2013: No significant change observed.						
09/13/2012: The site has been visited by land survey. The vegetation on the site shows the erosion has not developed significantly from the last survey.						
The site was not visited by boat survey due to the limitation of navigable waterway.						
08/23/2011: No significant change observed.						
9/22/2010: No significant change observed. There is moderate vegetation growth on the berm. Despite the erosion occurring on the berm, corrective action should be taken before the issue becomes severe.						
9/29/2009: Site is immediately downstream of a section of existing rip rap; there is a 20-foot berm remaining; berm will continue to erode unless erosion is mitigated; Site# is the same as RM62.6, LM1.87; recommended for annual assessment, per CES Evaluation 2008 Report

Close view of the site.

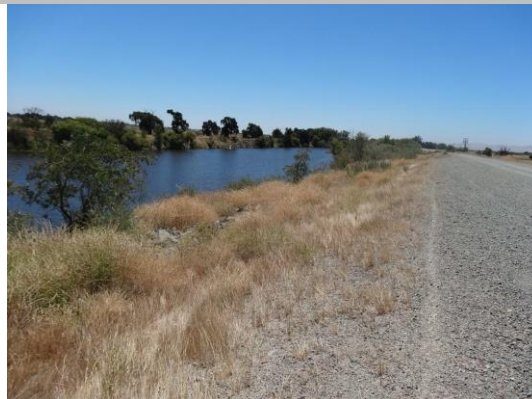
Photo 1 of 2 : SJR2016_RD2095U02RM60.69_1.jpg

Comment Code					
Inspector Comment					
07/20/2016: No significant change observed. Dense vegetation blocks the visual inspection at the site.					
08/04/2015: No significant change observed.					
7/02/2014: No significant change observed.					
08/28/2013: No significant change observed. Dense vegetation blocks the visual inspection at the site.					
09/13/2012: The site has been visited by land survey. The erosion is not visible from the levee slope because of dense vegetation at the site. Levee slope is protected by placed rocks. The site was not visited by boat survey due to the limitation of navigable waterway.					
08/23/2011: Dense vegetation makes it difficult to view the possible erosion. No new development was observed on site.					
09/23/2010: At the time of the inspection, the erosion site was difficult to view from the levee. The erosion is located on the bank toe, below the existing rip rap. There were no signs of repair on site, nor has the site been reported to be repaired by the district. Images taken from last year indicate that existing rip rap at the bank toe has sloughed exposing the underlying soils. Weakening of the toe could lead to future bank instability.

08/05/2010: Recommended for annual assessment and monitoring during flood events, per CLRO.					
09/29/2009: No major change observed since last visit; sloughing of the rip rap above toe; erosion begins immediately downstream of existing rip rap revetment; roughly 15-foot berm remains; however, it will continue to erode and eventually intrude into the levee profile if left untreated.					
10/20/2006: Just upstream of where berm starts to widen. [2016 Site ID:RD2095U02RM60.69]

View of the erosion from the downstream levee crest. The dense vegetation on the site blocks the view of the erosion.

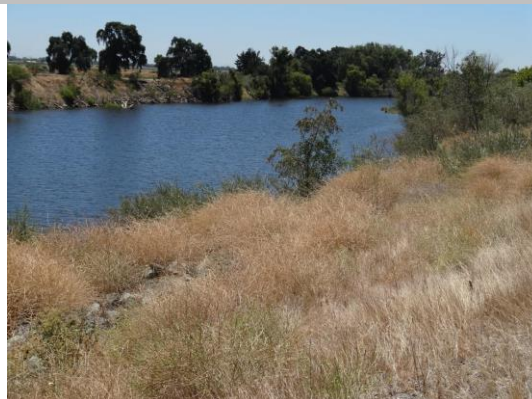
Photo 2 of 2 : SJR2016_RD2095U02RM60.69_2.jpg

The erosion is not visible from the levee top. The levee slope is protected by riprap rocks.

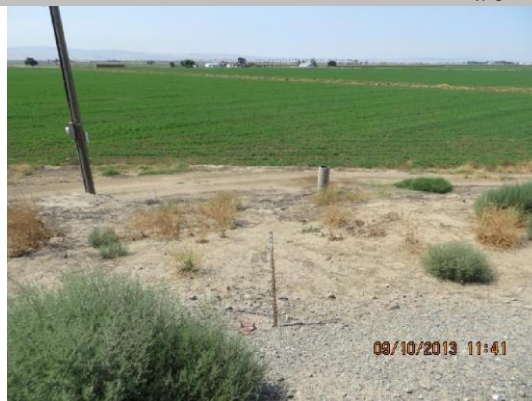
Photo 1 of 2 : UCIP_FA_2016_19867_33771.jpg

LM Start	2.08	Rating **	M	Issue No.	944
LM End	2.08	Issue Type +	En	Location *	WS
Category	Supplemental			GPS Latitude/Longitude	
				Start	End
Item	DWR UCIP Field Study			37.735416 °	37.735416 °
				-121.297860 °	-121.297860 °
DWR ID					
Comment Code					
Inspector Comment					
FS_ID:19867 DS_ID:21643 EP_NO: N/A Repair Type: Non-Urgent Crossing Status: Found UCIP Comments: Siphon breaker on LS shoulder does not appear to be functional. FIELD_STRUCT_DESC: 16-inch steel irrigation pipe through the levee 2.0-feet below the crown. Slant pump on steel platform on WS slope. Siphon breaker on the landward shoulder marked by T-post. Service pole and meter on the landward toe. Possible concrete standpipe on LS toe. Originally included in the 1968 O&M manual. FS Date: 9/10/2013

Siphon breaker on LS shoulder next to T-post with Power pole and concrete standpipe on LS toe.

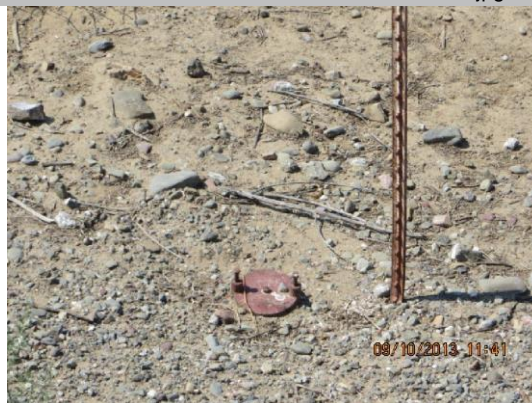
Photo 2 of 2 : UCIP_FA_2016_19867_33770.jpg

Siphon breaker on LS shoulder next to T-post.

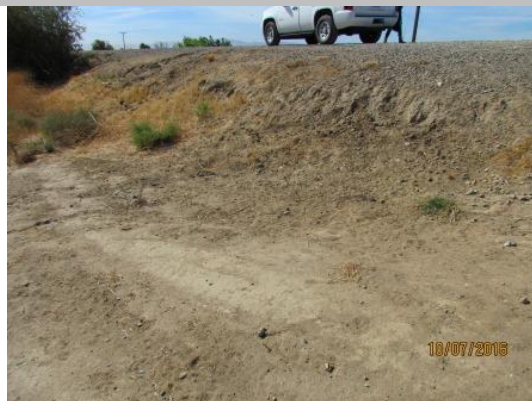
Photo 1 of 2 : FA_2016_RD2095_323_19_20161011_00023.jpg

LM Start	2.09	Rating **	M	Issue No.	19
LM End	2.09	Issue Type +	Ma	Location *	WS
Category	Earthen Levee			GPS Latitude/Longitude	
				Start	End
Item	Slope Stability			37.735276 °	37.735276 °
				-121.297777 °	-121.297777 °
DWR ID	DWR_RD2095_02_f_2016_19				
Comment Code					
S1 : Repair slope instability.					
Inspector Comment

View of the erosion on the waterside levee slope.

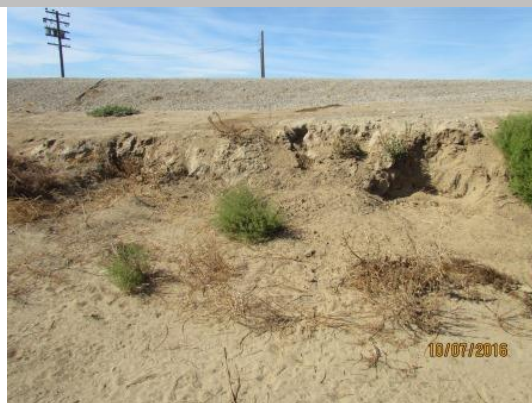
Photo 2 of 2 : FA_2016_RD2095_323_19_20161011_00024.jpg

View of the erosion caused by excavation on the waterside levee slope.

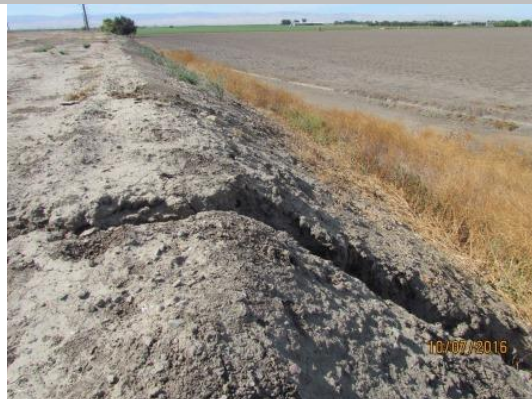
Photo 1 of 2 : FA_2016_RD2095_323_21_20161011_00025.jpg

LM Start	2.85	Rating **	M	Issue No.	21
LM End	2.85	Issue Type +	Ma	Location *	LS
Category	Earthen Levee			GPS Latitude/Longitude	
				Start	End
Item	Erosion / Bank Caving			37.724647 °	37.724647 °
				-121.299749 °	-121.299749 °
DWR ID	DWR_RD2095_02_f_2016_21				
Comment Code					
E2 : Schedule repair of erosion site prior to the next inspection.					
Inspector Comment

View of the landside levee slope erosion.

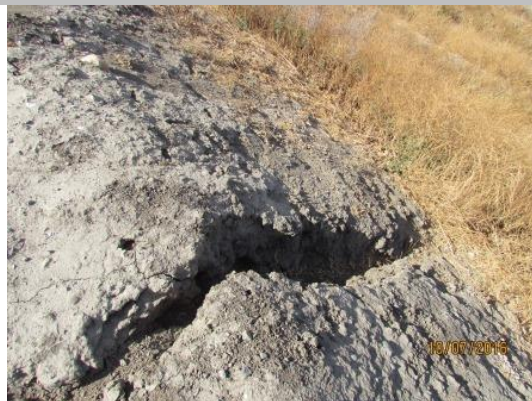
Photo 2 of 2 : FA_2016_RD2095_323_21_20161011_00026.jpg

Another view of the landside levee slope erosion.
